**FLORIDA OPERATIONS  
NASA SHUTTLE LOGISTICS DEPOT  
MATERIALS AND PROCESSES  
TEST REPORT**

FA No: 00-087  
Sub-CAR: KB4157-014  
PRR: 95904M  
NR: N/A

NOMENCLATURE/SUBJECT: **Evaluation of Bulkhead Penetration Line, P/N MC271-0085-1016,  
S/N 52054000004**

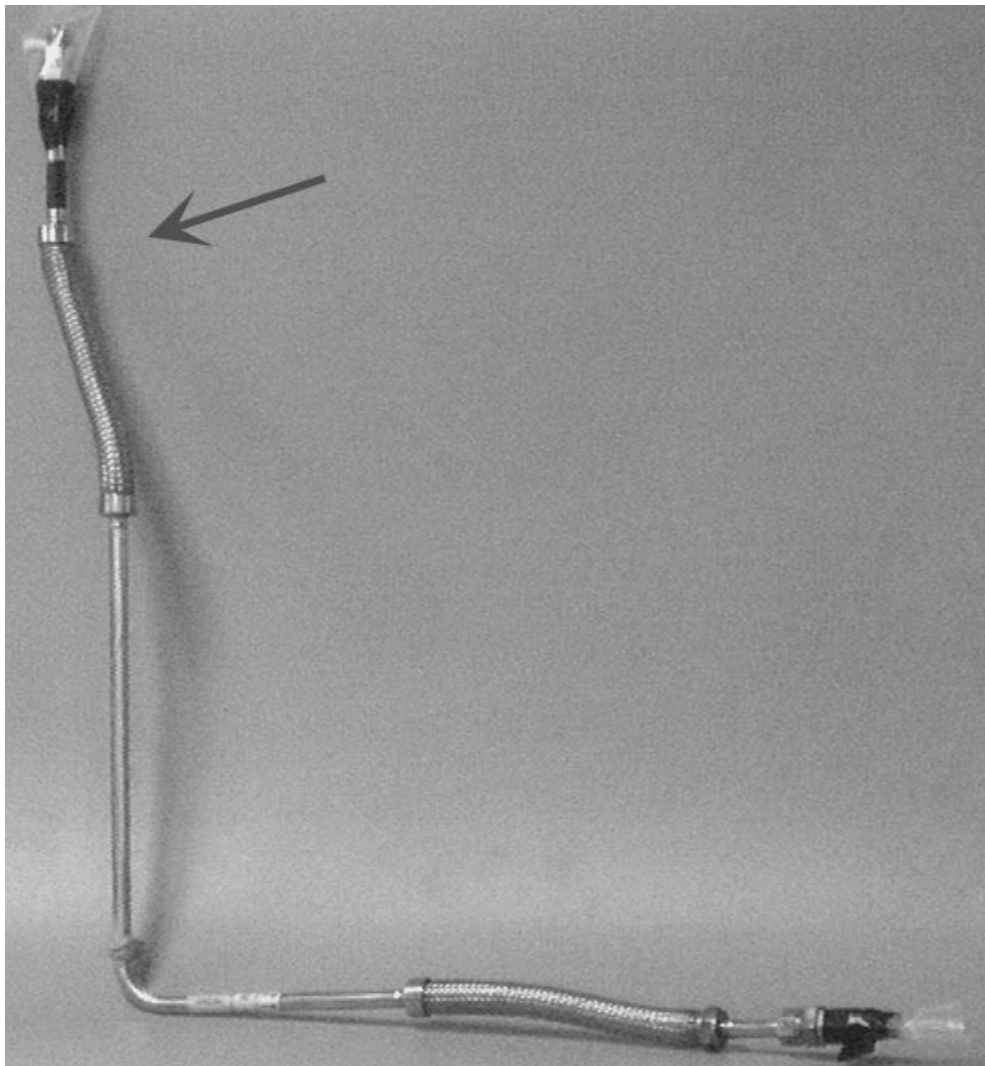
The hose was received marked with a piece of tape indicating the leak occurred in the end of the hose which was mounted to the payload bay floor, see Figure 1. The other end of the hose is

**Figure 1:** Overall view of flex hose. Arrow indicates area where leakage was detected.

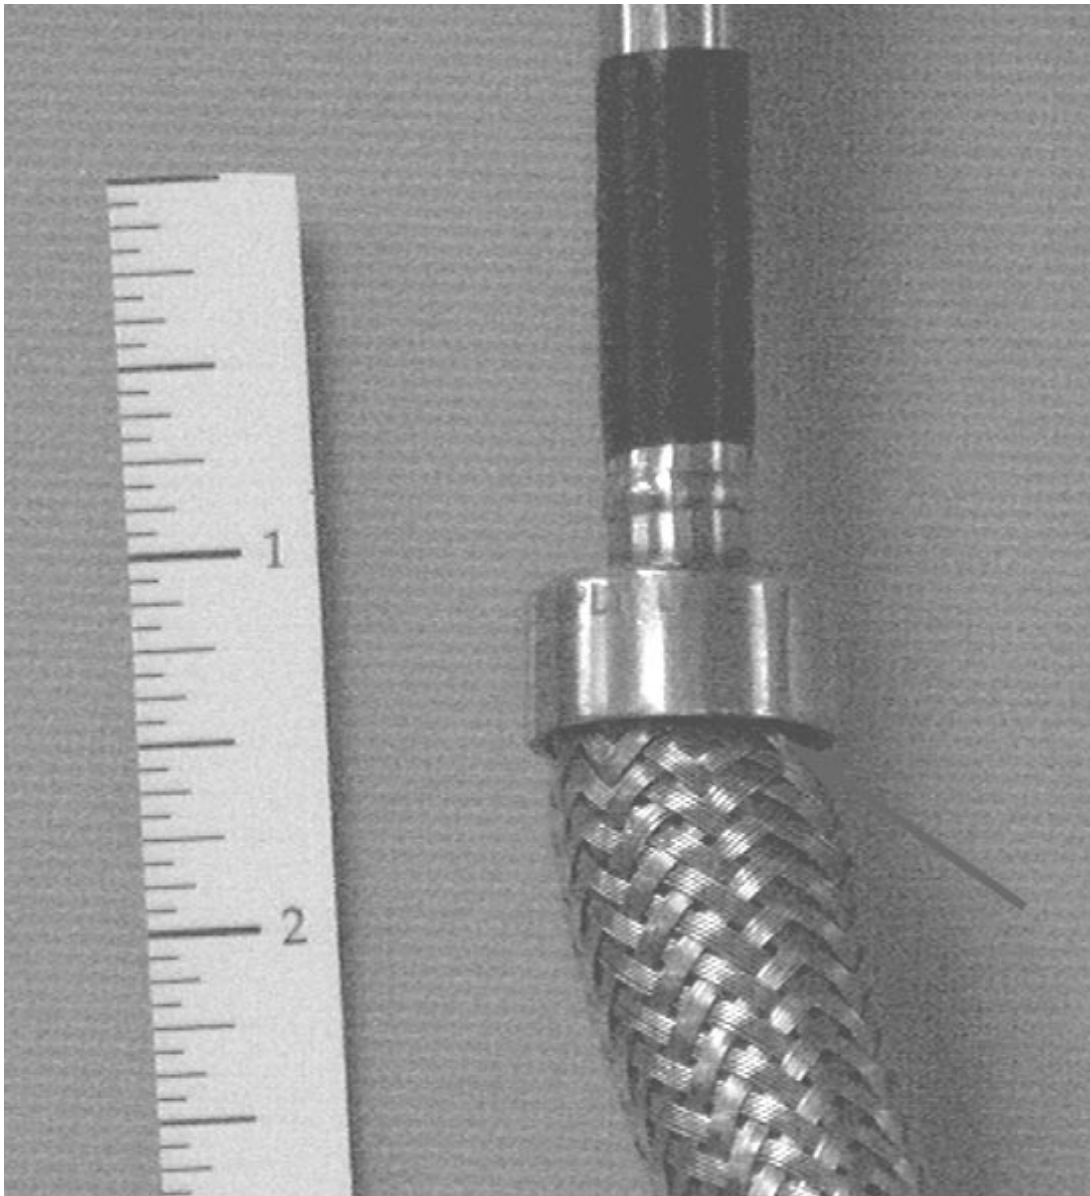
The hose was then leak tested using GN2. At 5 psi a blowing leak was detected under the fitting on the end of the hose, as seen in Figure 1, and Figure 2. The initial radiography did not evaluate the area under the fitting. Radiography was again performed concentrating on the leaking area of the hose and a fractured convolute was evident in one view. The failure occurred in the valley of the first convolute after the weld joint which attaches the tube and bellows.

**Figure 2:** Closeup of Figure 1. Arrow indicates leakage from ruptured bellows convolute located under fitting.

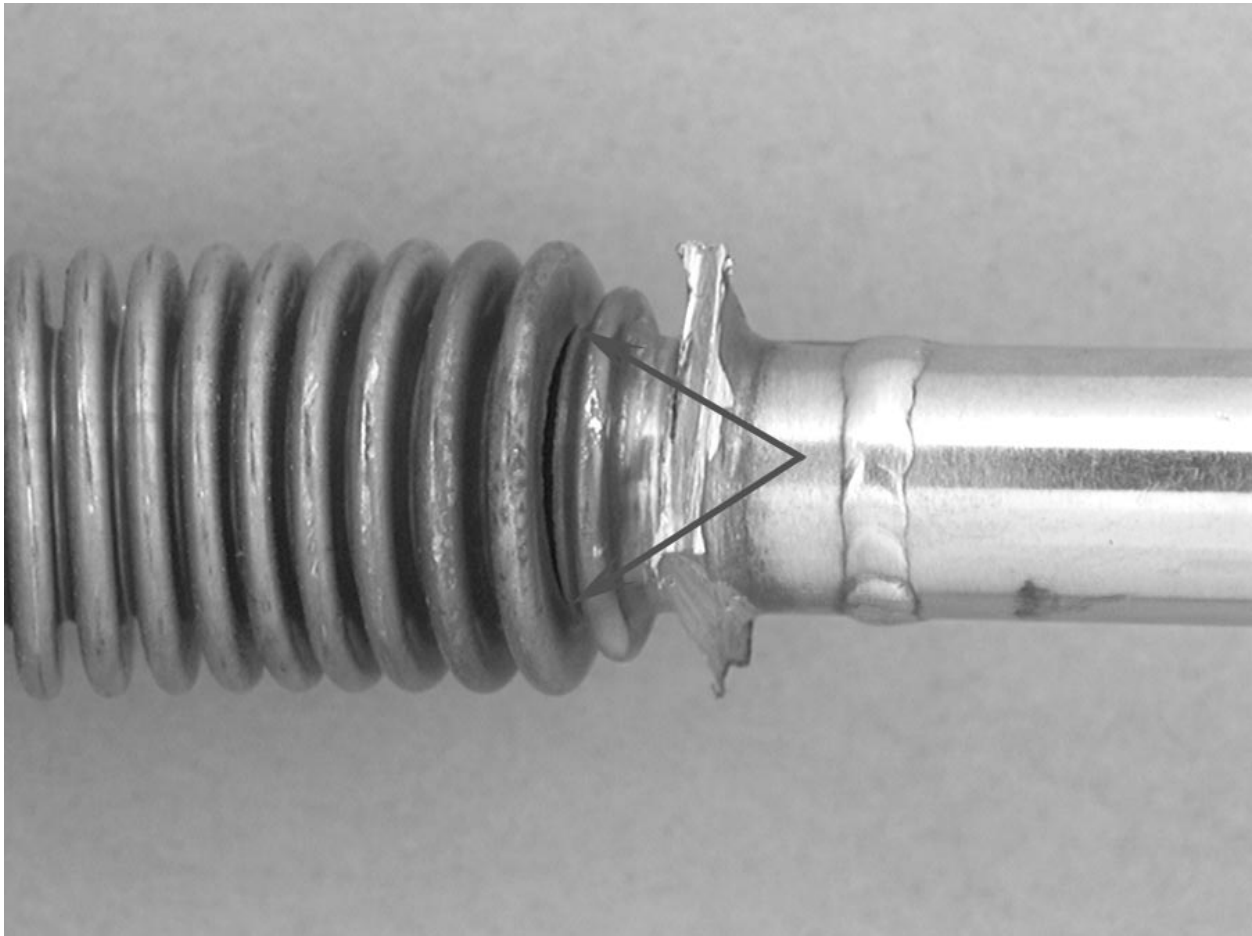
The failed convolute was examined at 20 to 50X and revealed a rupture in the bellows approximately 60 degrees long. Figure 3 shows the location of the failure behind the weld joint as well as the rupture in the valley of the convolute. Further inspection revealed a hairline crack which did not penetrate the base metal that extended approximately another 210 degrees, see Figure 4. The crack also followed what appeared to be a forming mark in the valley of the convolute. A detailed photograph of the forming mark could not be obtained on the optical microscope due to part size, geometry and lighting effects.

**Figure 3:** Ruptured convolute in valley of bellows

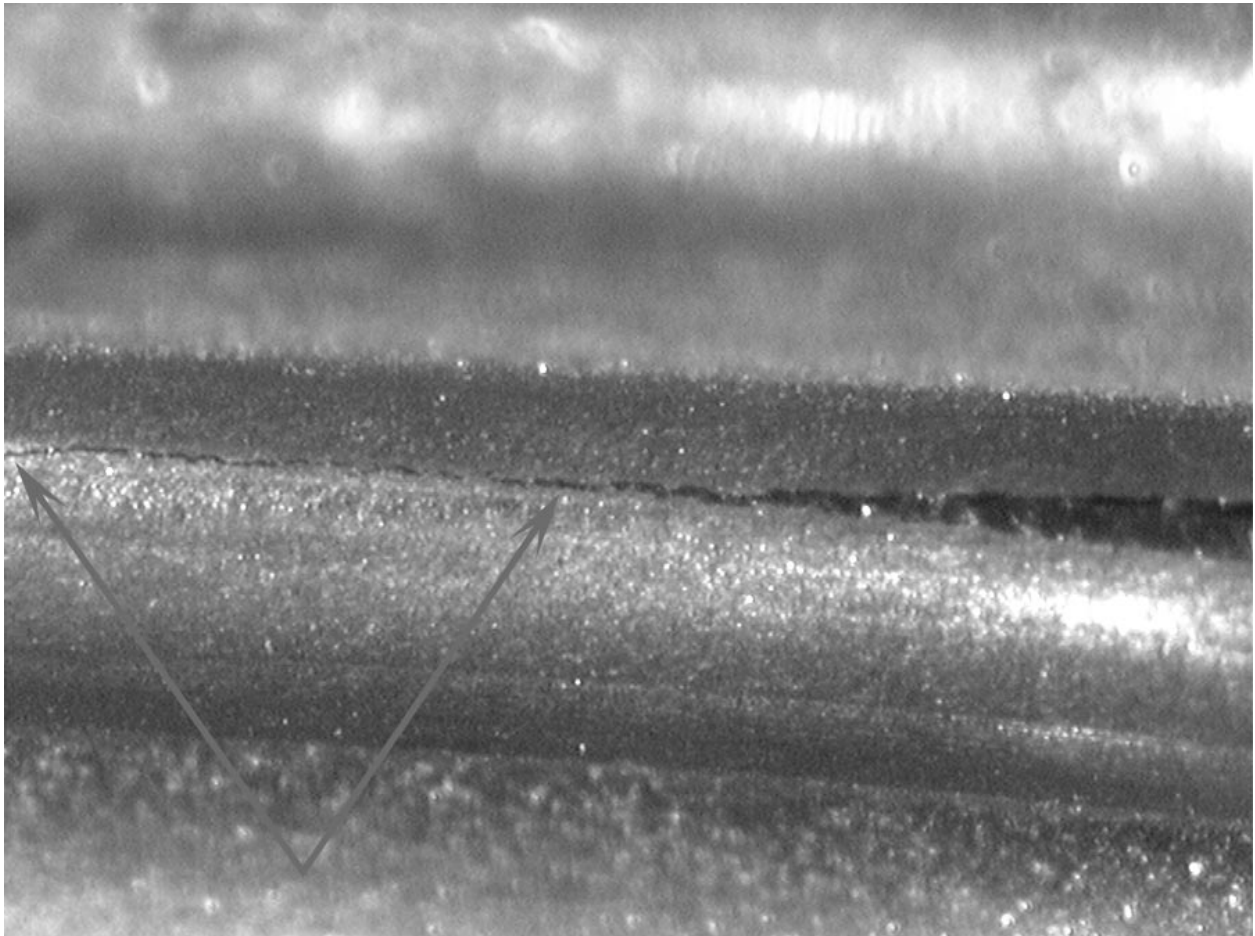
**Figure 4:** Hairline crack which continued from ruptured surface for an additional 210 degrees.

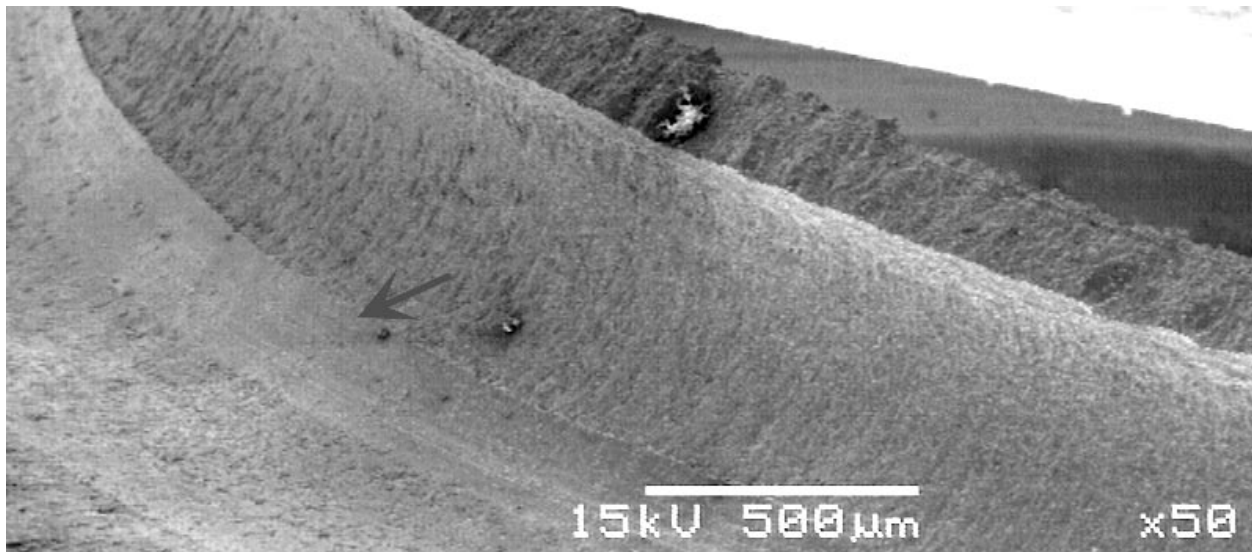
The fractured convolute was mounted for analysis of the fracture surface utilizing the JEOL 5800 LV SEM. A representative photograph of the forming mark along which cracking occurred is shown in Figure 5. Examination of the fracture surface in the ruptured convolute exhibited fatigue striations, refer to Figure 6.

The failure appeared to have initiated by surface cracking which resulted from the cyclical bending applied to the hose. The crack on the outer convolute followed a forming mark which acted as stress concentration point. The cyclical bending caused stress concentrations on the inner and outer surfaces of the failed convolute, which caused small cracks to form on these surfaces as seen in the metallographic inspection Figure 9. Eventually, multiple cracks were formed, each serving as an origin for the propagation of the fatigue striations which resulted from the flexural cycling.

**Figure 5:** Arrow indicates forming mark along which crack propagated.

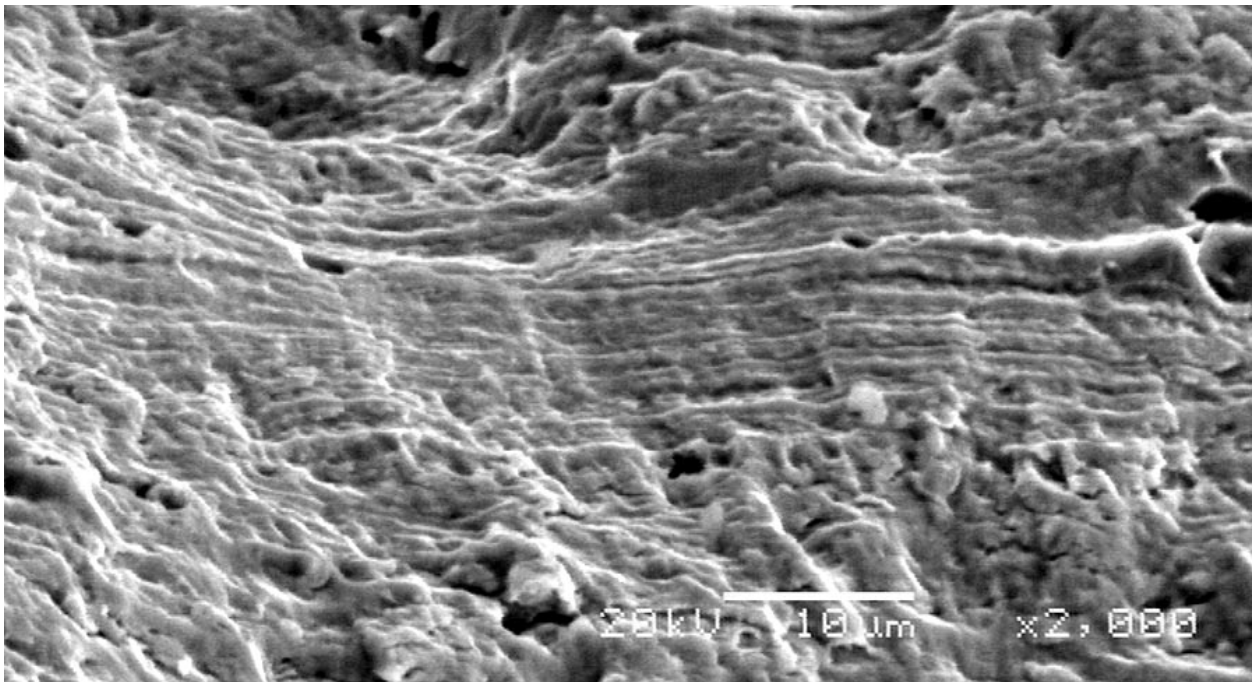
The leakage failure of the flex hose was due to fatigue as evidenced by the fatigue striations which propagated through the bellows convolute on the inner and outer diameters until failure occurred, see Figures 6 and 7. The end of the hose which failed is configured in such a way that it is allowed to flex in three axes. The failed hose was also subjected to many cycles as it is an original hose installed on OV-104 and has been in service for 20 missions. The hose is also subjected to pneumatic, vibration and temperature cycling during operation which could have also contributed to the failure.

**Figure 6:** Fatigue striations on the outer diameter of the failed convolute.

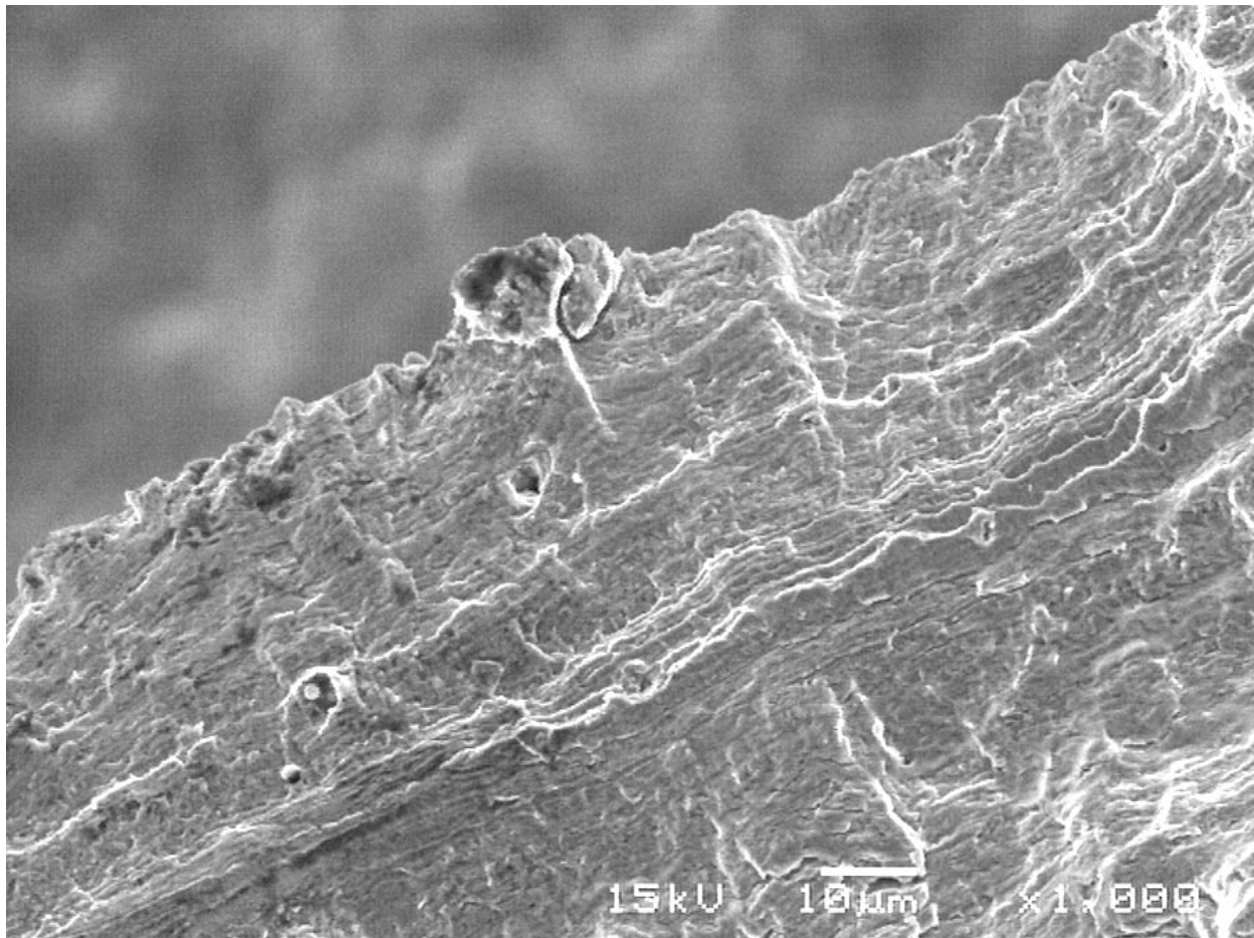
The fatigue striations in the ruptured area as well as multiple origins were evident. The striations appeared to initiate from the OD. Further evaluation revealed areas where it appeared the striations originated from the ID as well as the OD, refer to Figure 7.

**Figure 7:** Fatigue striations on the inner diameter of the failed convolute.

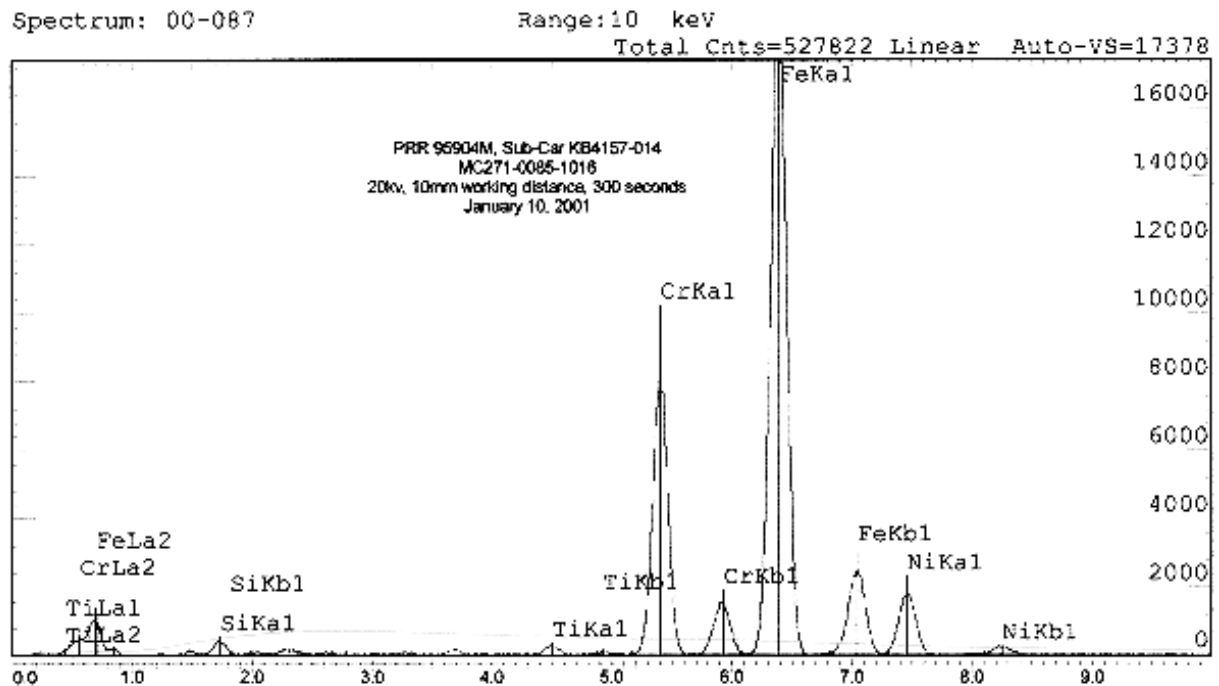
Qualitative chemical analysis was performed utilizing the JEOL 5800 LV SEM and Kevex Super Dry energy dispersive x-ray spectrometer. SEM/EDS analysis showed no corrosion products on the fracture surfaces. Qualitative chemical analysis indicated the bellows was 321 stainless steel as a spectrum of Fe, Cr, Ni and Ti were obtained, see EDS plot in Figure 8.

**Figure 8:** EDS plot of bellows material.

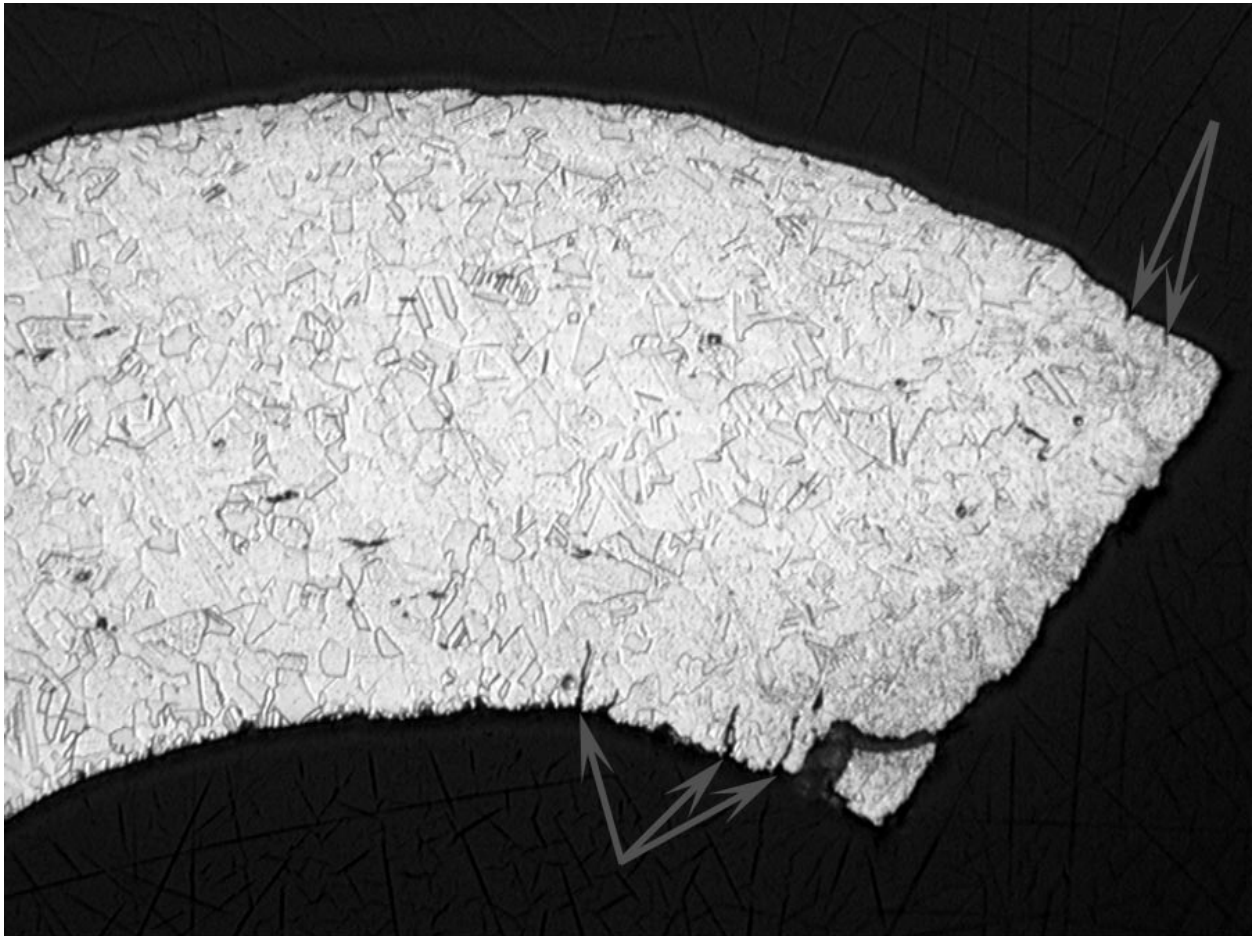
A transverse section of the bellows was removed and mounted for metallographic examination to inspect the inner and outer surfaces. The sample was polished and etched using methanolic aqua regia to reveal the microstructure. The microstructure was typical of an austenitic stainless steel and can be seen in Figure 9. The specimen also revealed cracking adjacent to the fracture surface on the OD and ID, see Figure 9.

**Figure 9:** Photomicrograph of failed convolute. Arrows indicate cracking on outer and inner diameters.
